PNE-516  
FINAL REPORT

# PROJECT PRE-SCHOONER II

## POSTSHOT GEOLOGIC AND ENGINEERING PROPERTIES INVESTIGATIONS

PROJECT PRE-SCHOONER II  
POSTSHOT GEOLOGIC AND ENGINEERING  
PROPERTIES INVESTIGATIONS

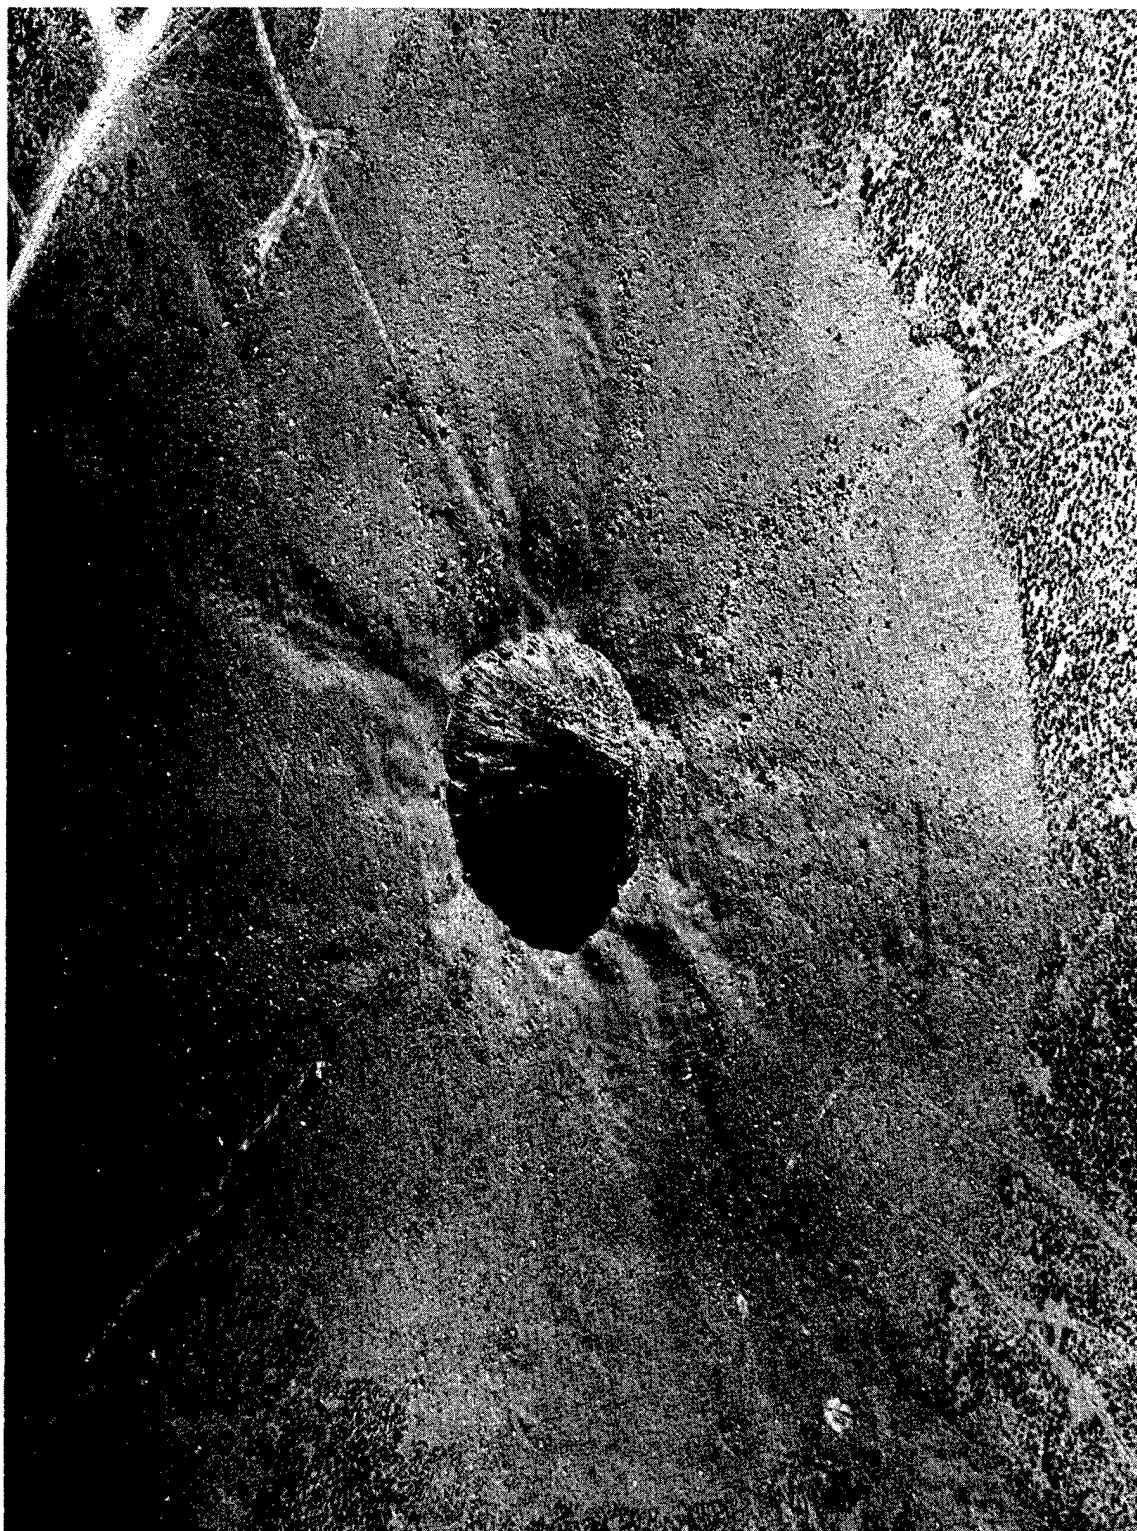
Pre-Schooner II Crater.

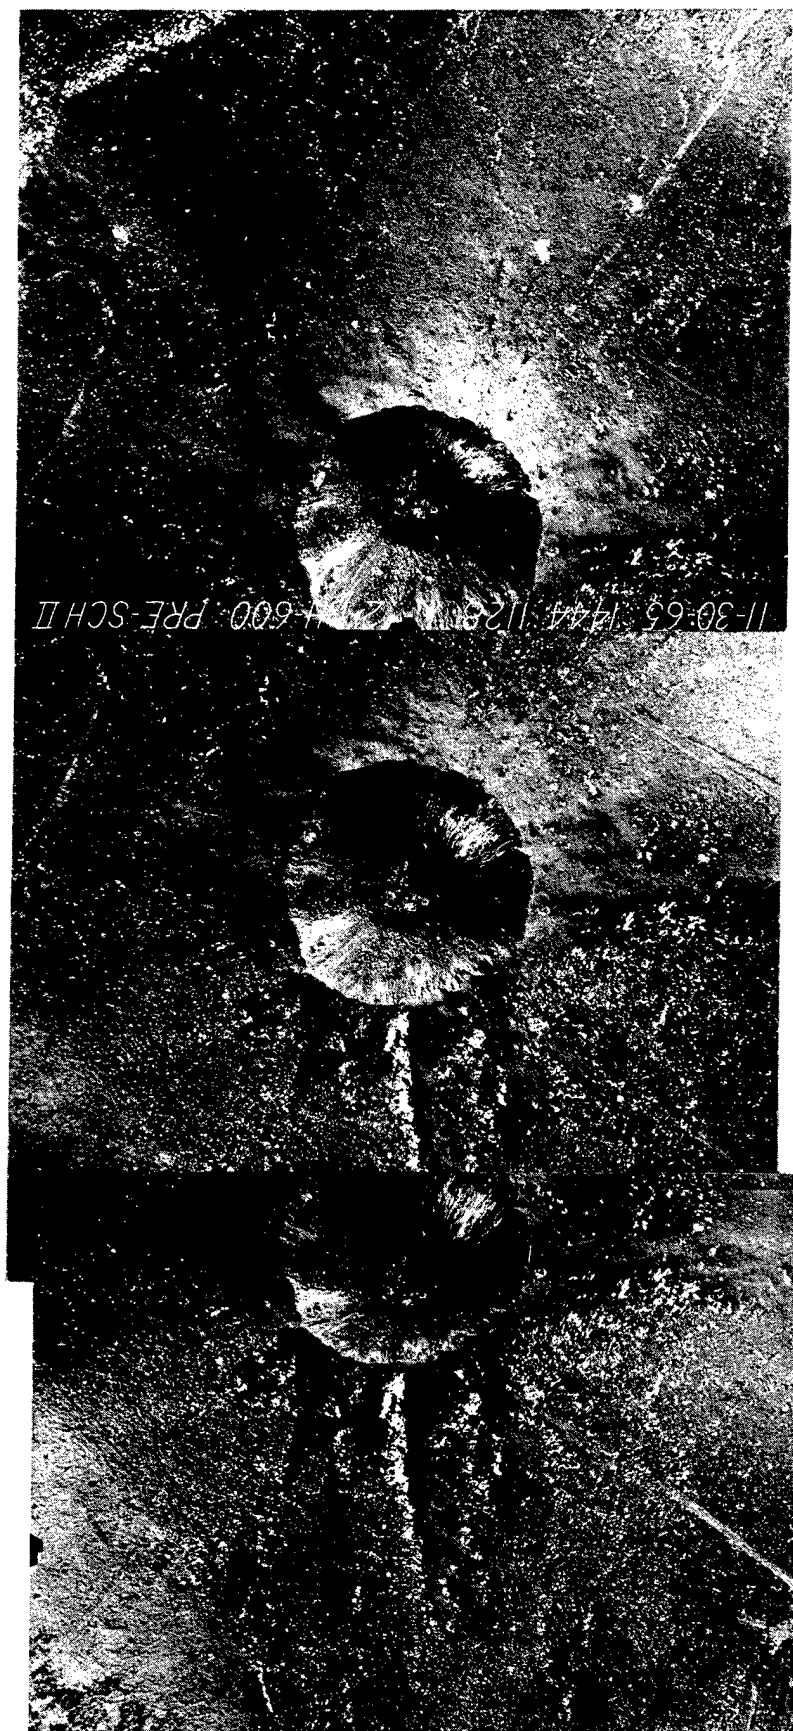
Figure 3.2 Postshot aerial photo prior to commencing excavations (photos grouped for stereoscopic viewing).

possible. A final aerial photograph and map were made at the completion of all excavation. Photographic stereoscopic pairs of the excavation phases, and corresponding topographic maps, are shown in Figures 3.2 through 3.7.

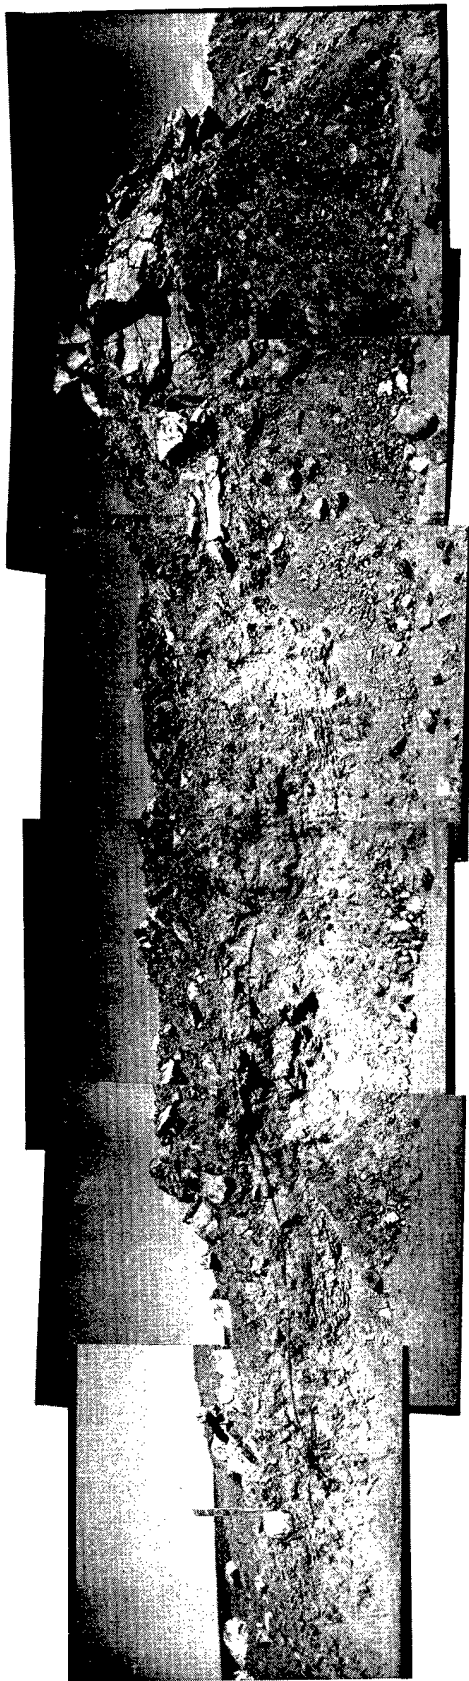
Figure 4.6 Ground profiles from Trench No. 1.

After the trenches were excavated, one wall of each trench was examined and mapped to delineate the true crater boundary and amount of uplift. The results of this mapping are shown in Figures 4.6 through 4.9 for Trenches No. 1, and No. 3. The true crater radius and amount of uplift are listed in Table 4.4.

From an examination of the trench profiles, it can be seen that in all three trenches the soil and caliche have been removed from above the uplifted bedrock for a distance of 8 to 24 feet back from the true crater zone. This condition is probably the result of surface spalling. In Trench No. 1 there has also been overthrusting of wedges of material which, prior to the detonation, constituted the ground surface closer to SGZ.

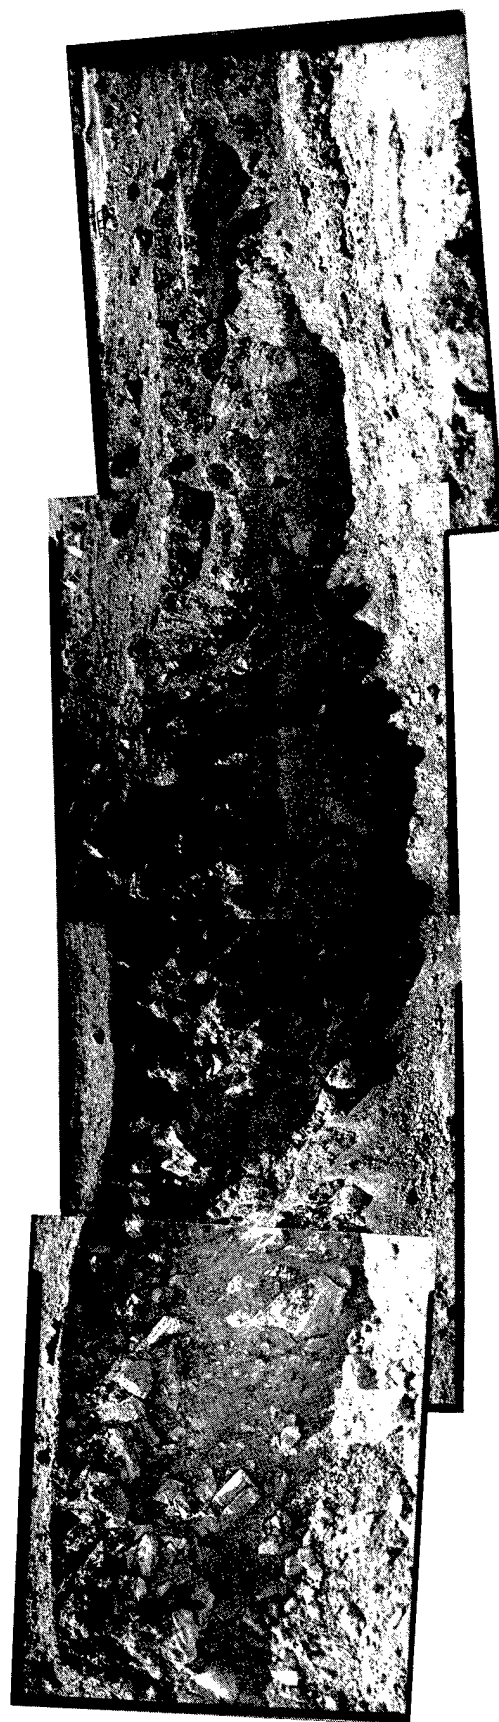
Figure 4.7 Ground profiles from Trench No. 2, west wall.

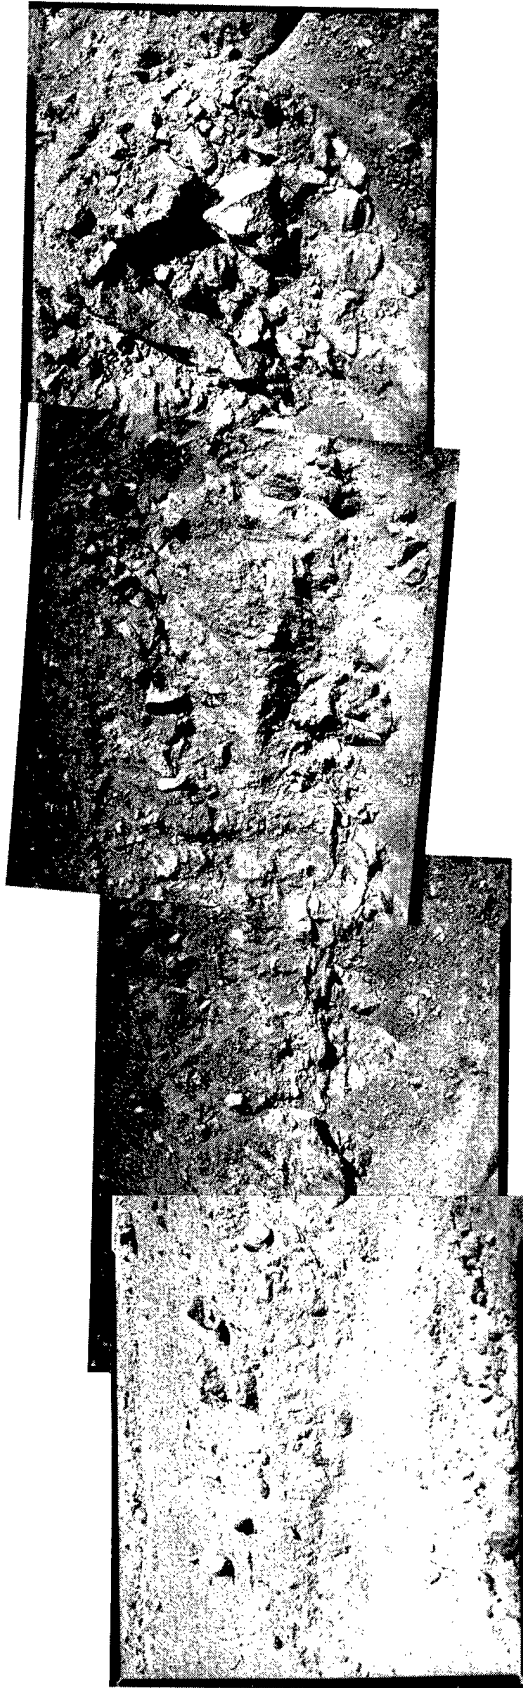
Figure 4.8 Ground profiles from Trench No. 2, east wall.

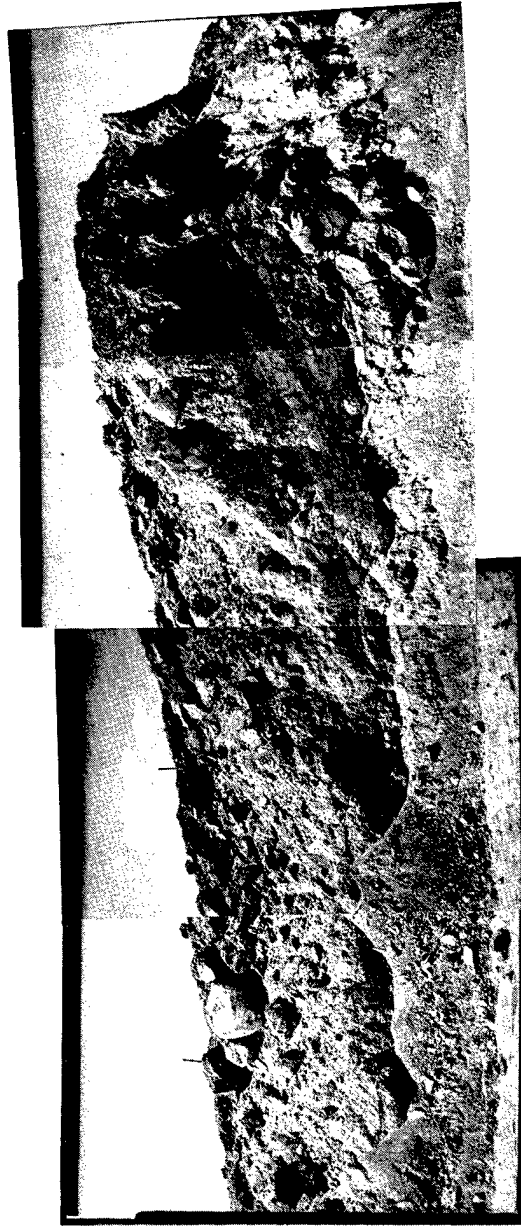
Figure 4.9 Ground profiles from Trench No. 3.
